# Manhole Inspection Summary

Manhole # S17AA\_016MH

Insp Date: **4/13/09 2:19 PM**

**Location** Address: **REAR 2500 LAFAYETTE AVE**

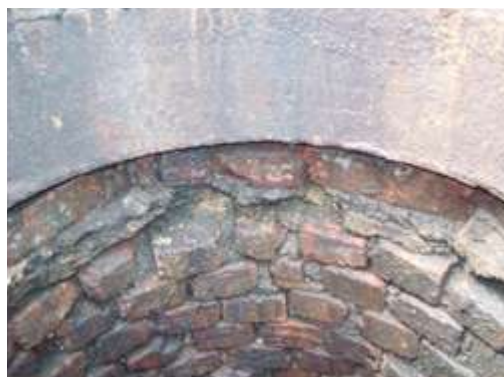
Defect 1

Condition: ☐ Sound ☐ Cracked ☐ Root Intrusion ☒ **Loose Brick** ☒ **Deteriorated**

CORBEL LOOSE  
BRICKS/DETERIORATED CORBEL

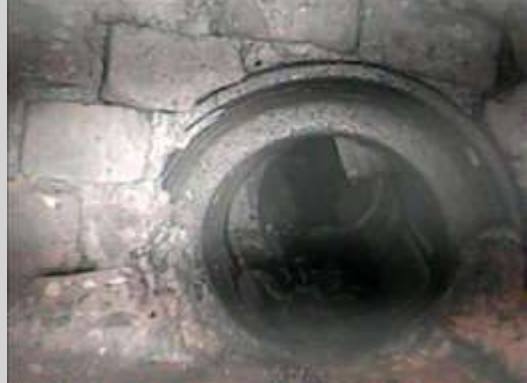
12 O'Clock Outflow

8 in. Circular Gravity Sewer  
Pipe Out @ 12 O'Clock

Infiltration: **None** Pipe Seal Cond: **Sound**
